FINAL REPORT FOR REMEDIATION OF LOCATIONS IN GRANITE CITY, MADISON, AND VENICE, ILLINOIS ASSOCIATED WITH NL INDUSTRIES/TARACORP SUPERFUND SITE

PRE-PLACED CONTRACT NO. DACA45-96-D-0014 DELIVERY ORDER NO. 0011

OHM Remediation Services Corp.

October 5, 1998 Project 20366

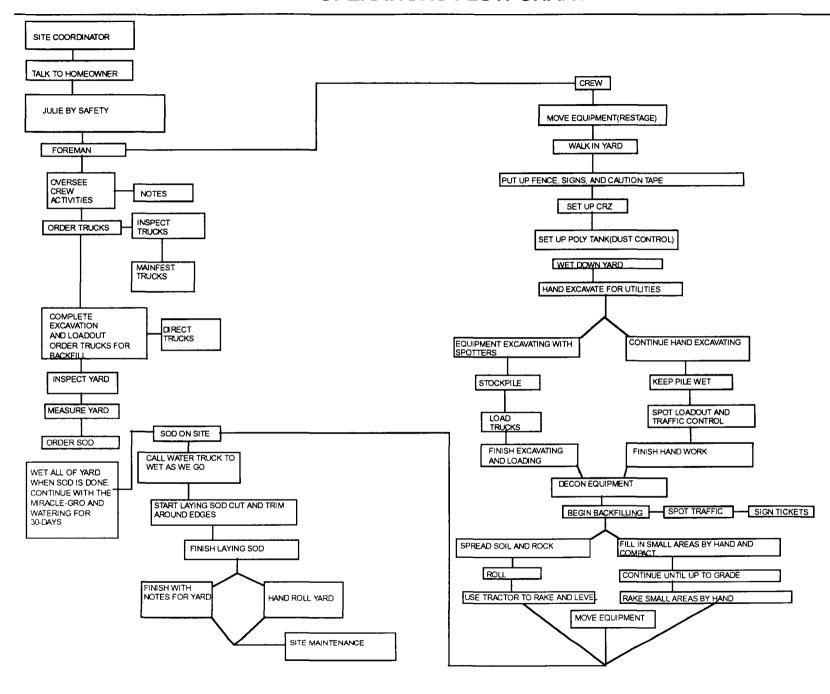
OPERATIONS FLOW CHART

The excavation activities involved the removal of contaminated soils from the remedial sites. Restoration involved backfilling, seeding, and sodding of the sites after completing the remedial activities. The scope of work for this portion of the project is illustrated in Figure 2.1.1 The operations Flow Chart is depicted in Appendix A-1.

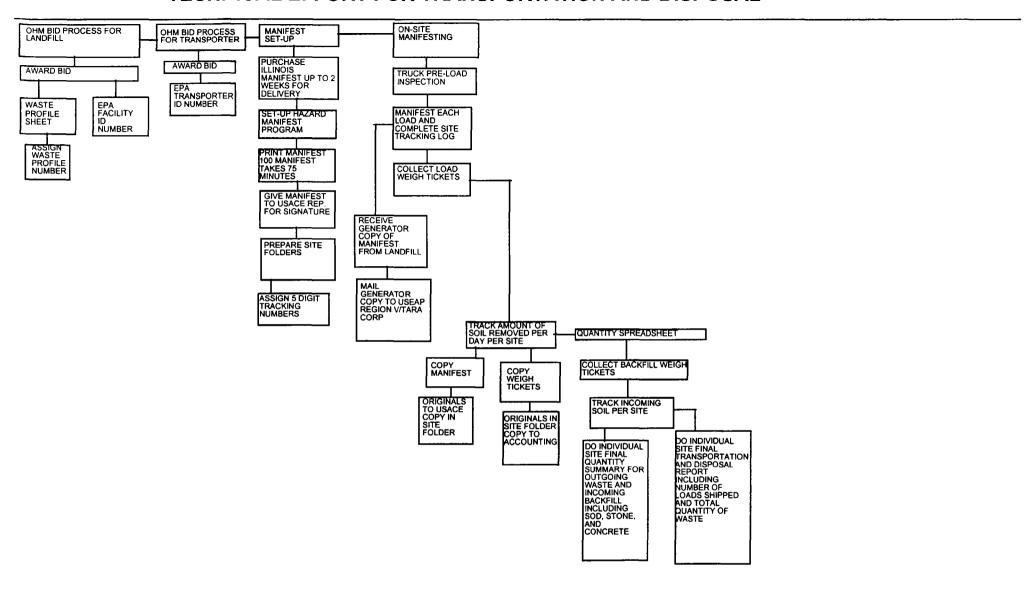
TECHNICAL EFFORT FOR TRANSPORTATION AND DISPOSAL

Wastes removed from the sites were transported to one of two locations. Milam RDF/Chain of Rocks. Figure A-2 in Appendix A shows the flow chart for T&D.

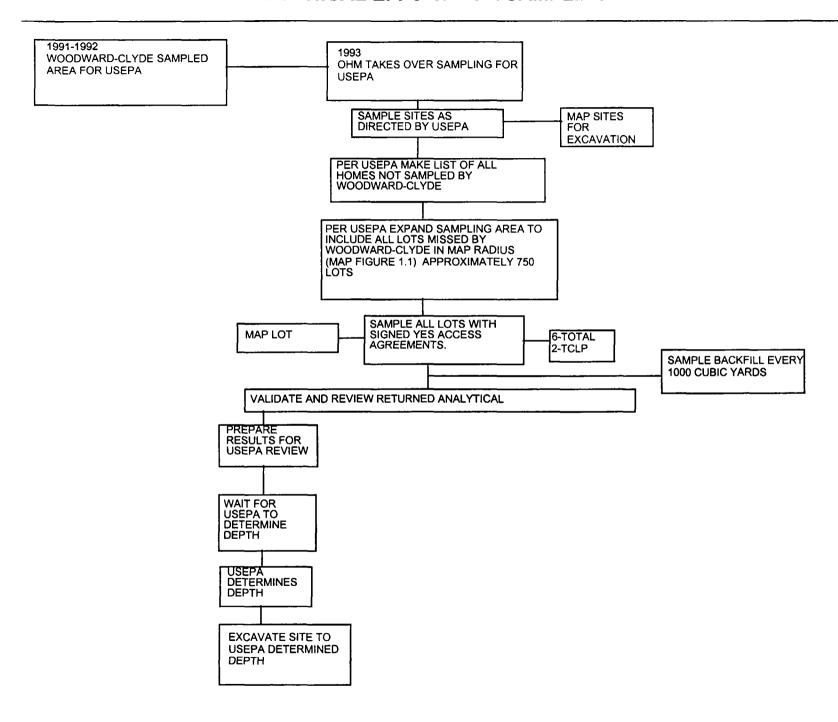
TECHNICAL EFFORT FOR SAMPLING

Pre-characterization sampling and analysis at the residential lots included the establishment of two sample locations at each site. The two sample points were positioned at the center of the front and back yard of each location. One sample was then collected at the following depths from each sample location: 0 to 3 inches, 3 to 6 inches, and 6 to 12 inches.

The laboratory analysis of the samples followed the logic as below. The two samples representing the top 3-inch layer of each of the locations were analyzed for total lead and toxicity characteristic leaching procedure (TCLP) lead. The second and third set (representing 3 to 6 and 6 to 12 inch depths) were analyzed for total lead only.

This is depicted in Figure A-3 in Appendix A.
